Application Spotlight: A Case Study on Aging Pipelines using Remote Video

In This Issue:

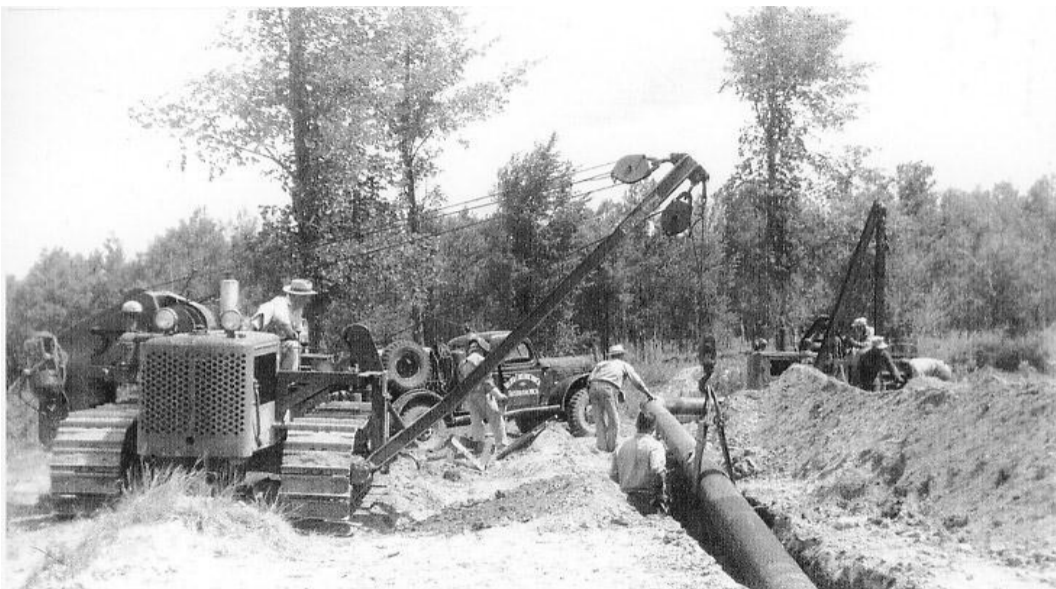
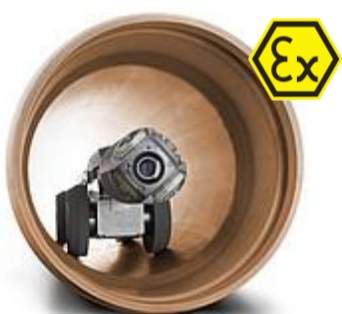
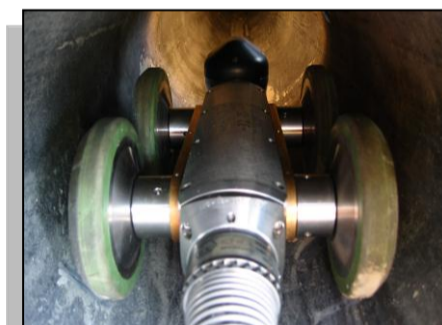
The Solution: Remote video inspections are an alternative method to inspecting various sized pipelines. Robotic crawlers, track or wheeled configurations, and push system cameras can be introduced into the pipelines to gather live video of the pipeline's internal conditions. The video observations obtained from these rugged tools can also confirm any changes in the pipeline size, coating materials, configuration of the pipeline or tie-in points. They can quantify build-up, and measure defects. Video crawlers can also confirm data provided by the engineers and integrity specialist, or from other NDT results, such as smart pigs, showing damaged internals. Maverick Inspection Ltd. carries Class1/ Division 1 and Explosive Proof crawlers for hazardous environments. This is important when dealing with H2S, Benzene and other toxic substances.

The Result: Remote video crawlers and push system cameras provide the engineers and integrity specialists with a video observation of the pipeline conditions; The DVD footage of the video inspection is easily viewed by the client to further their evaluation of conditions of the lines so that they may proceed with other actions such as repairing the line, cleaning the line or replacing the line. Digital reporting (Images) and laser profile reporting can also be implemented using video crawlers to provide further information showing the true ID, and deformation of pipelines. These robotic systems are quick to deploy without delays to the client.

The Problem: Many of today's pipelines in the Canadian fields have been buried for over 50 years. The problem in most cases is that the available pipeline drawings, showing the pipeline material, configurations, tie-in points, internal coatings, pipe size changes, elevations and the locations of the lines are misplaced or lost. The aging pipelines do occasionally run into problems such as internal corrosion, fouling, stuck pigs, collapses and other failures. Where this is the case, smart-tools such as in-line pigging cannot adequately log information required by the engineers and integrity specialists.

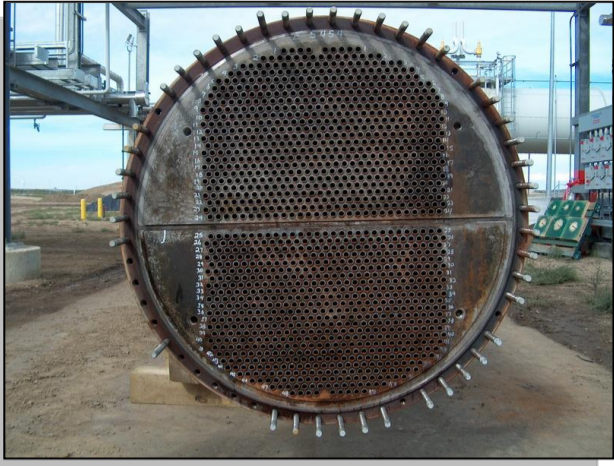
Exchangers-Verify Cleaning & Defects

Exchangers, Condensers, Fan Fin Coolers and Reactor tubes are commonly cleaned during turnaround outages without the client really knowing what condition they are in prior or after cleaning. Maverick Inspection uses small diameter video-scopes to observe the tubes internal conditions. This technology can help set cleaning run times for cleaning companies, confirm internal surface wear damages from other NDT results or to just perform a general observation of the tubes conditions for determination of others methods of testing.

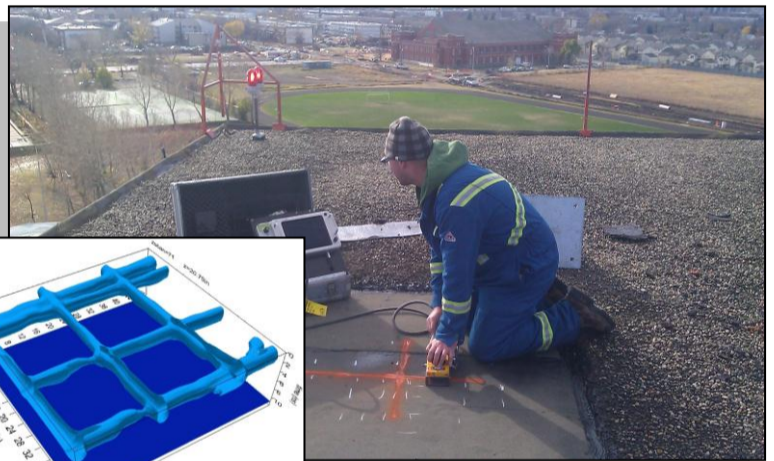
GPR – Roof Scanning –Anchor/ Duct Work

High-rise buildings are continuously going through renovations and new construction on the roof tops. Ground Penetrating Radar can scan the roof floor for confirmation of the rebar patterns, conduits and post-tension cables before coring or cutting for purposed additions of the roofs floor for towers, ducts, anchor points and window washing stations. The software interpretation and 3D profile reporting can give the clients a broader approach to understanding what lies beneath without potential hazards.

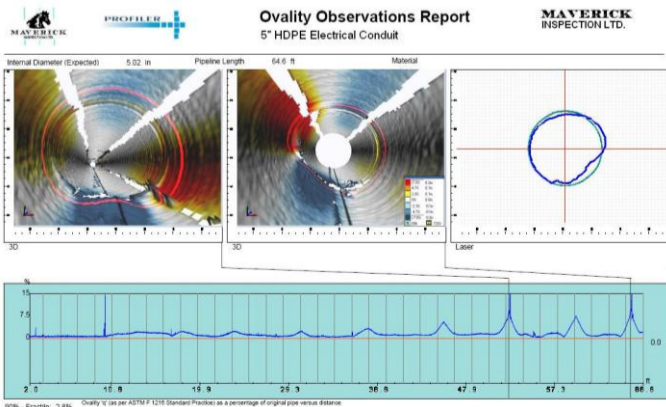
Laser Profiling Pipe / Pipelines

The laser profiler is a Snap-On tool onto our existing robotic crawlers that displaces an illuminated ring of light on the pipe wall surface. The information gathered from this is interpreted through Machine Vision software to observe any changes within the cross section of the pipe for any deformations, true 'ID', and to quantify build up before after cleaning.
