MAVERICK NEWSLETTER

Application Spotlight: A Case Study of Pipe Deformations

GPR- Rebar Placement Quality Assurance - Bridge Girders

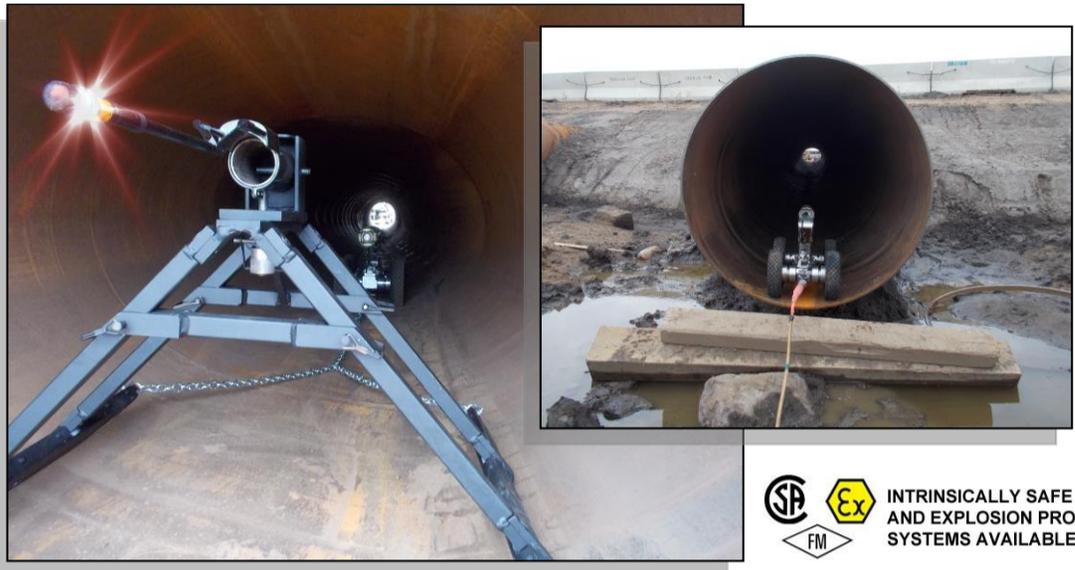
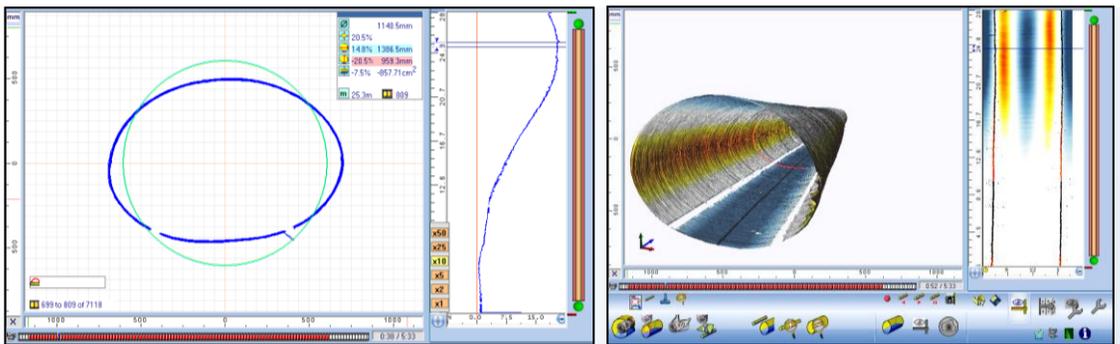
A total of four passes, two from either end of the cast iron sleeve, were laser-profiled and video-inspected showing multiple areas of pipe sleeve with continuous deformations.

During the internal inspection of the metal sleeve, real-time video captured and recorded the laser-ring projected onto the pipe-wall surface while pulling back the laser-skid with the remote crawler. The recorded video documentation of the laser-projection was later transferred into a 3D machine-vision software which outputs various measurements and results, helping engineers to determine the exact starting and ending of the deformations with cross-sectional measurements and capacity reports. The ovality (out-of-roundness) of the sleeve was measured as high as 20.5% of the pipe diameter, leaving 79.5% of the pipe diameter available.

The Horizontal Directional Boring of the sleeve commenced and followed through to the other side of the highway where it was extruded with noticeable deformations. The internal diameter ended up at only 1000mm on the other side of the highway. Engineers and consultants were wary about the possibility of even more damage to the pipe. Could it still be used to pull through the planned utilities despite the deformations?

Maverick furnished the clients with a user-interactive disc including the 3D reporting so they could make the necessary adjustments for the new utilities to be installed with precision. The inspection revealed that even with the visible deformations of the pipe that no additional boring, no re-work and no new construction were required, saving the client thousands of dollars, and all without disrupting the flow of traffic along the highway.

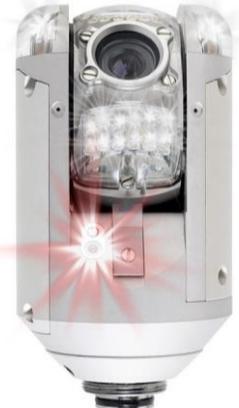
Maverick has added to its growing arsenal of CSA EX video inspection systems, Canada's first CSA Approved V2.7 small diameter pan & tilt camera with zoom for hazardous environments. This small, robust and versatile EX camera head can inter-change quickly and attach itself to either a robotic video crawler or push system or can be deployed as a drop camera. The inspection applications that are best suited for deploying EX camera systems would include pressure vessels, towers & stacks, injection lines and pipelines with multiple bends. The camera is also equipped with measuring capabilities using an onboard laser to provide clients with pipe lateral size and internal diameters.
