In This Issue:

Application Spotlight: A Case Study of Storage Tank Build Up

RVI : Large Opening Inspections using RVI Zoom Cameras

GPR : Profiling Ice Thickness – Ice Roads, Frozen Rivers & Lakes for Safety

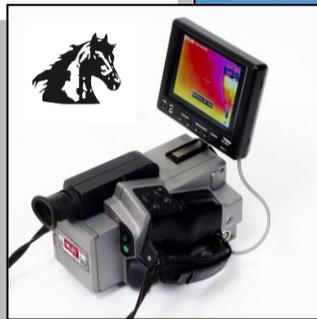
Maverick Inspection used thermal imaging technology to scan the outside of the tanks and map out the paraffin levels. The high temperature differentials between atmospheric conditions and the product temperature created an ideal thermal signature. This allowed not only for the paraffin levels to be mapped out, combining dip values with perimeter signatures, but even for bottoms such as sand and/or water to be noted. The client was able to provide the information to engineers who modelled the deposits in 3D software, taking the tank bottom profile, tank dimensions, dip values, and thermal signature data into account and then quantifying the paraffin.

A Canadian company had crude oil storage tanks in a facility in Africa. They knew that they had significant paraffin build-up that diminished the tank capacity and would require cleaning and recovery of product from the paraffin. Determination of the paraffin volume was required to plan and tender the project.

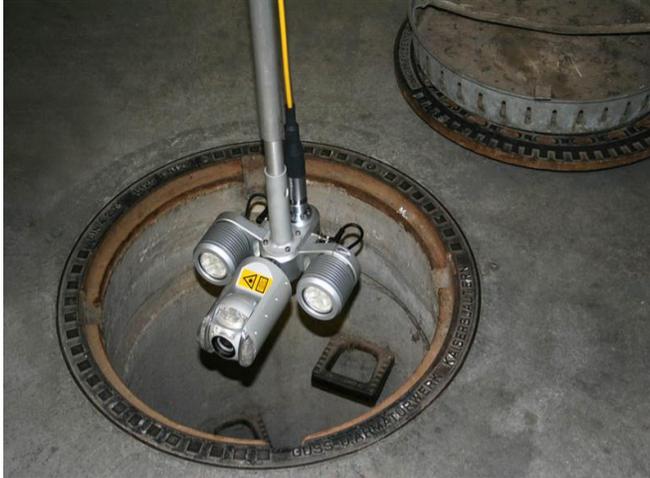
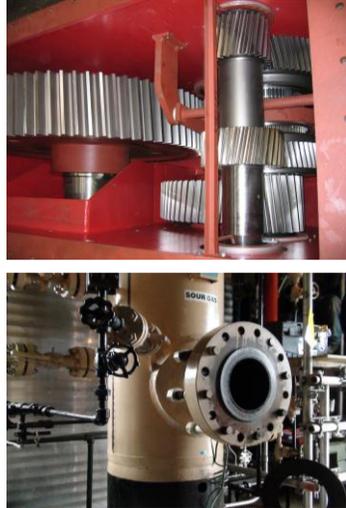
Robotic pan/ tilt/ zoom cameras are ideal for vessels, flare stacks and underground systems, eliminating the need to send personnel into a hazardous or confined space environment. The deployment on these high resolution camera systems are quick and are easily accessible through openings as small as 3". The PTZ cameras offer full color high resolution imaging with high intensity lighting to illuminate large surface areas to observe internal conditions.

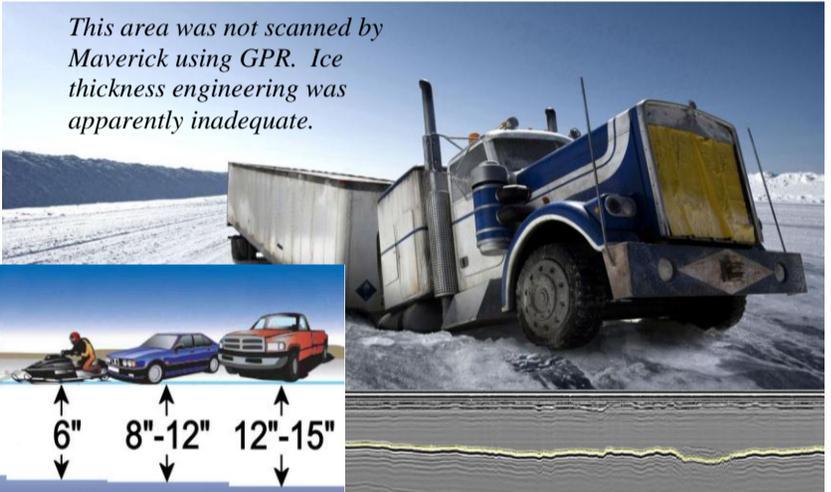
This area was not scanned by Maverick using GPR. Ice thickness engineering was apparently inadequate.

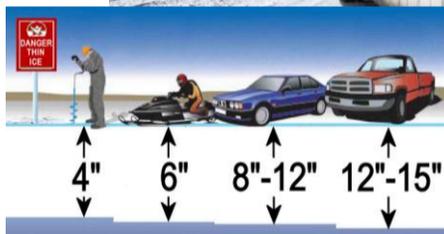
Maverick has the capability of performing Ground-penetrating Radar on ice roads, rivers, lakes and other frozen bodies of water to determine the thickness of the ice. When combined with core samples, this allows a 100% clear picture of the ice-thickness profile, providing far more information than cores alone can achieve.

Data Gathered by Maverick Inspection, 2011
