Application Spotlight

Long-Range Inspection in Remote Locations

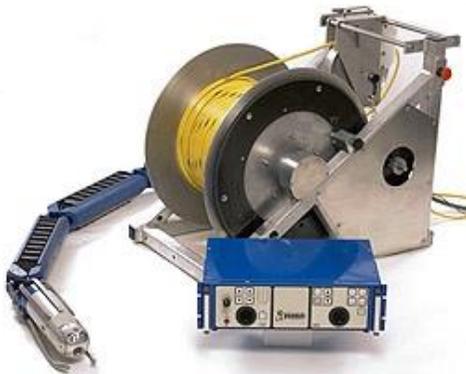
One concern was that the internals of the casings contained a preservation fluid which had been dye tested green. This could have severely limited the effectiveness of the camera inspection. At Maverick's Edmonton location, the Research & Development Team created a short section of the correct diameter and type of pipe to test the robotic crawler against a sample of the fluid. This ensured the inspection would yield the best possible results.

The test determined that the pan, tilt, and zoom camera head could indeed see clearly through the liquid. A recording of this test was provided to the client prior to dispatching the crew and equipment. Maverick coordinated the logistics and shipping of the equipment to Atlantic Canada, and the inspection of the casings was a success. The video inspection revealed that sandy debris was in fact present within several of the casings, even after the pigging process. This could have created a problematic situation where the friction from the cable pull could have worn the internal coating of the casing.
